CAD -269- DEPARTMENT OF ENVIRONMENT AND NATURAL RESOURCES - REGION III	DESIGNATION: BLLM No.177
	PAGE: 77 / 99

CONTROL POINT
Bureau of Lands Location Monument (BLLM)

ISLAND:	LUZON	CITY / MUNICIPALITY:	STA. ROSA
PROVINCE:	NUEVA ECIJA	BARANGAY:	INSPECTOR

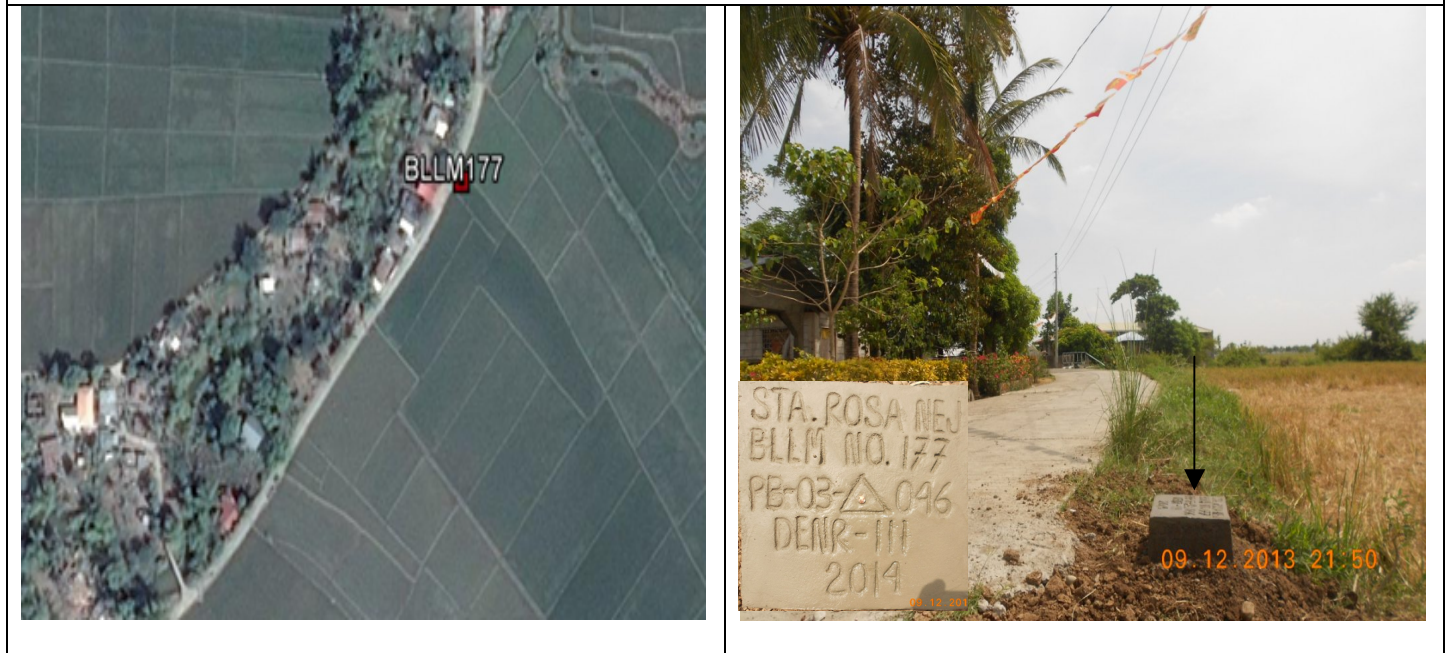
PHOTO / SKETCH

DESCRIPTION:
Mark is the head of a 3" copper nail embedded and centered on a 25X 25cm (top) by 35X35cm(base) by 120cm(height) standard concrete square base frustum, set on the ground with protruding 20 cm on the surface with inscriptions..."STA.ROSA NEJ BLLM NO.177, PB-03-000046 DENR III 2014".

ACCESS:
The monument is located along the right side of the barangay road going to Brgy. Inspector Proper. It is 250 meters after the Brgy. Hall of Inspector and is 800 meters from the Sta. Rosa-Tarlac Road.
