CONTROL POINT
Bureau of Lands Location Monument (BLLM)

ISLAND:	LUZON	CITY / MUNICIPALITY:	STA. ROSA
---------	-------	----------------------	-----------

SURVEYED/ DESCRIBED BY:	GeoIDEx	DATE ESTABLISHED:	April 28-May 17, 2014
--------------------------------	---------	--------------------------	-----------------------

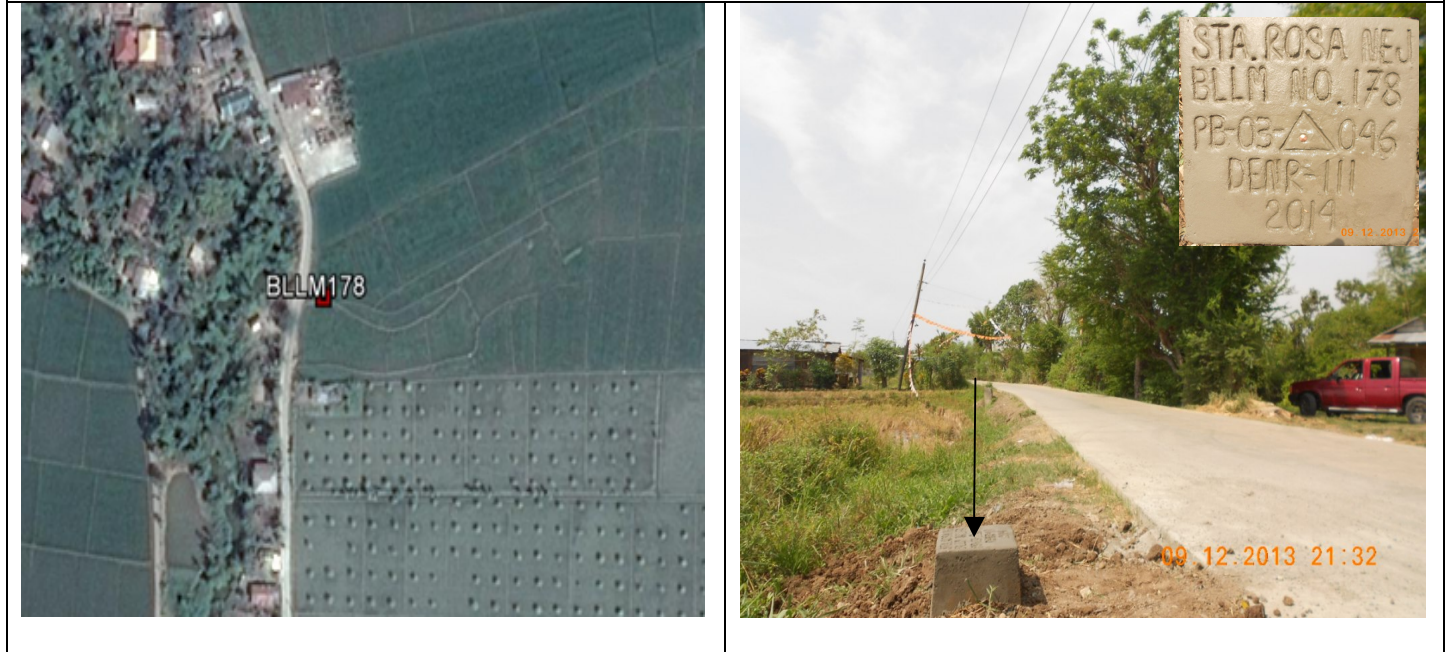
PHOTO / SKETCH

DESCRIPTION:
Mark is the head of a 3" copper nail embedded and centered on a 25X 25cm (top) by 35X35cm(base) by 120cm(height) standard concrete square base frustum, set on the ground with protruding 20 cm on the surface with inscriptions..."STA.ROSA NEJ BLLM NO.178, PB-03-000046 DENR III 2014".

ACCESS:
The monument is located along the right side of the barangay road going to Brgy. Inspector Proper. It is approximately 1 Kilometer away from the Sta.Rosa-Tarlac Road.
