CAD-225: DEPARTMENT OF ENVIRONMENT AND NATURAL RESOURCES - REGION III		DESIGNATION: BLLM No.62	
		PAGE: 3 / 69	
<p>THE POINT IS MEASURED AND PERMANENTLY MARKED IN 2014</p> <p>GAPAN CADASTRE</p>		<p>GEOGRAPHIC COORDINATES (WGS 84)</p> <p>Φ = N15°18'50.46214" λ = E120°57'06.03119"</p>	
<p>GEOGRAPHIC COORDINATES (OLD)</p> <p>Φ = λ =</p>		<p>GEOGRAPHIC COORDINATES (PRS 92)</p> <p>Φ = N15°18'56.04894" λ = E120°57'01.19782"</p>	
<p>GRID COORDINATES (PTM) in Meter</p> <p>N = 1693719.506 E = 494666.370</p>		<p>GRID COORDINATES (PTM) in Meter</p> <p>N = 1693719.506 E = 494666.370</p>	
<p>LOCAL COORDINATES (20000,20000) in Meter</p> <p>X = Y =</p>		<p>ELEVATION in Meter</p> <p>Above mean sea level 23.763</p> <p>Ellipsoidal Height 25.179</p>	
CONTROL POINT			
Bureau of Lands Location Monument (BLLM)			
ISLAND:	LUZON	CITY / MUNICIPALITY:	GAPAN
PROVINCE:	NUEVA ECIJA	BARANGAY:	SAN LORENZO
DESCRIPTION:			
<p>Mark is the head of a 3" copper nail embedded and centered on a 25X 25cm (top) by 35X35cm(base) by 120cm(height) standard concrete square base frustum, set on the ground with protruding 20 cm on the surface with inscriptions..."GAPAN CITY NEJ BLLM NO.62, CAD 225 DENR III 2014".</p>

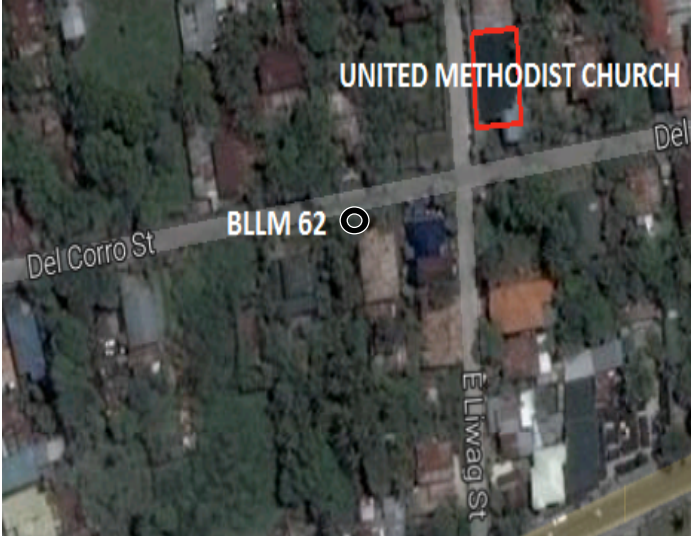
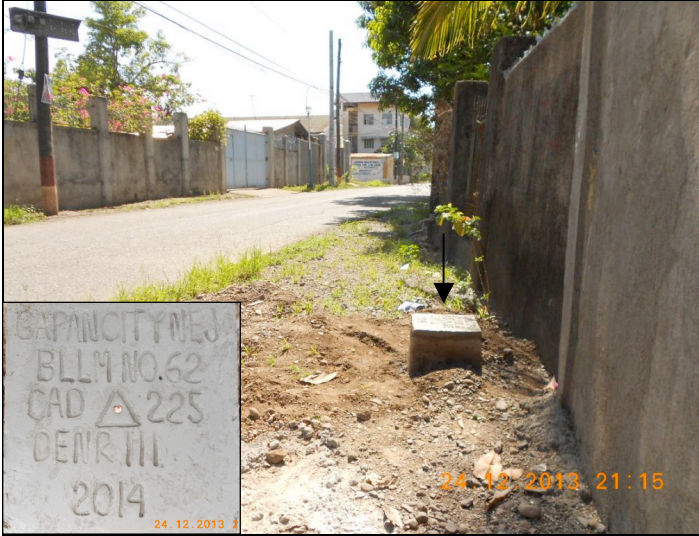
ACCESS:			
<p>The monument is located along Del Corro Street in front of a residential house, approximately 50 meters away from the United Methodist Church across the E. Liwag Street.</p>			
SURVEYED / DESCRIBED BY:		GeolDEx	DATE ESTABLISHED: April-June 2014
PHOTO / SKETCH
