CAD-225: DEPARTMENT OF ENVIRONMENT AND NATURAL RESOURCES - REGION III	DESIGNATION: BLLM No.90
	PAGE: 31 / 69

**CONTROL POINT
Bureau of Lands Location Monument (BLLM)**

ISLAND:	LUZON	CITY / MUNICIPALITY:	GAPAN
PROVINCE:	NUEVA ECIJA	BARANGAY:	MALIMBA

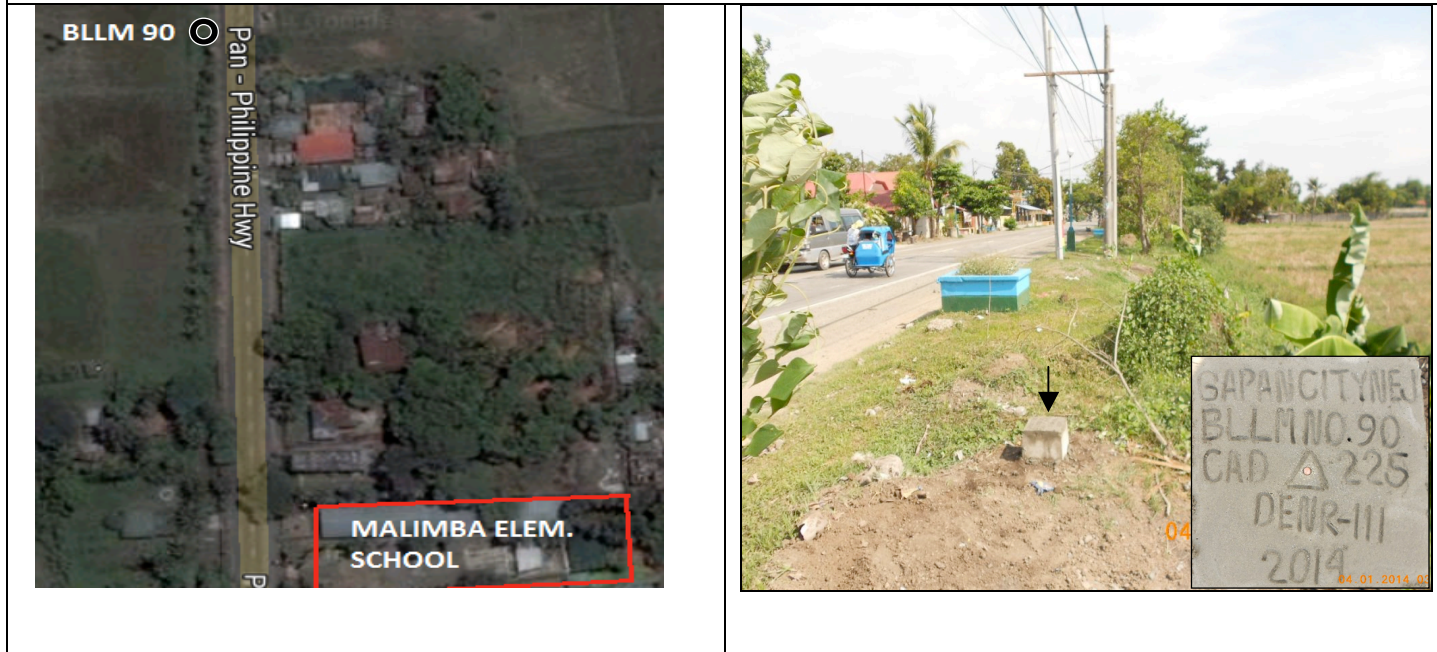
PHOTO / SKETCH

DESCRIPTION:
Mark is the head of a 3" copper nail embedded and centered on a 25X 25cm (top) by 35X35cm(base) by 120cm(height) standard concrete square base frustum, set on the ground with protruding 20 cm on the surface with inscriptions..."GAPAN CITY NEJ BLLM NO.90, CAD 225 DENR III 2014".

ACCESS:
The monument is located along Pan Philippine Highway beside a concrete plant box approximately 200 meters before the Brgy. Hall of Malimba.
