CAD-225: DEPARTMENT OF ENVIRONMENT AND NATURAL RESOURCES - REGION III	DESIGNATION: BLLM No.91
	PAGE: 32 / 69

CONTROL POINT			
Bureau of Lands Location Monument (BLLM)			
ISLAND:	LUZON	CITY / MUNICIPALITY:	GAPAN
PROVINCE:	NUEVA ECIJA	BARANGAY:	MALIMBA

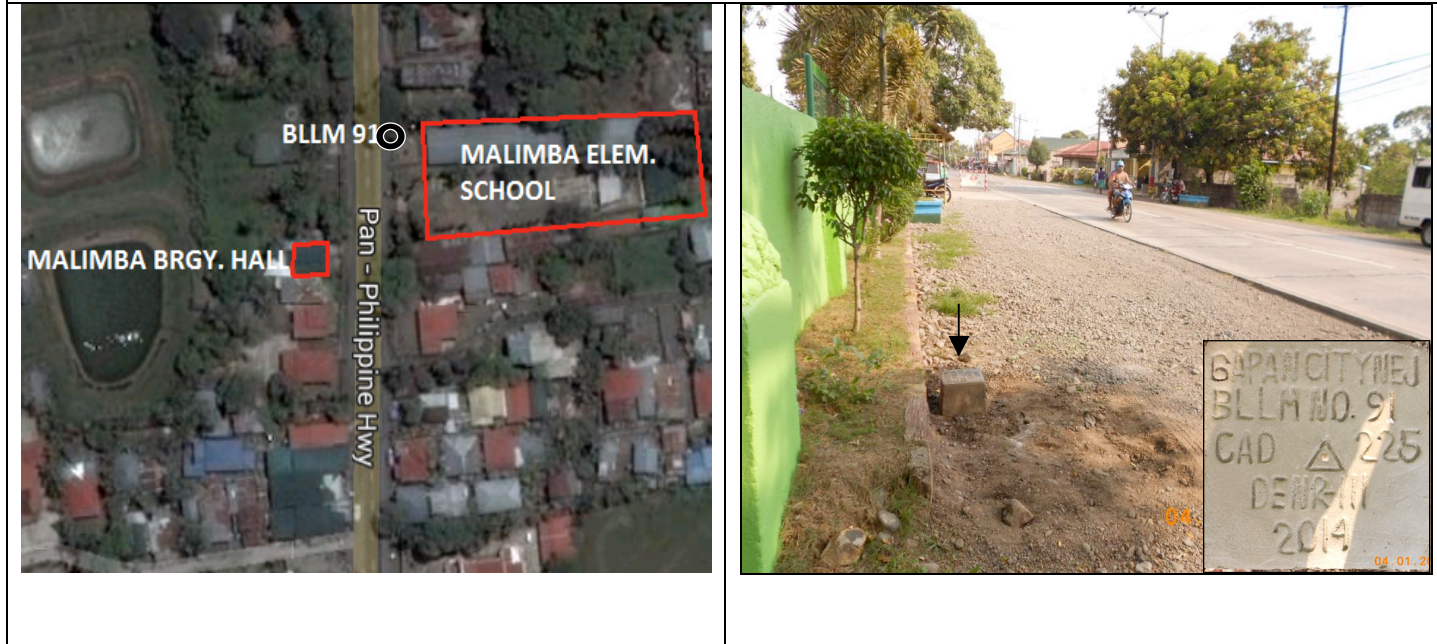
PHOTO / SKETCH

DESCRIPTION:
 Mark is the head of a 3" copper nail embedded and centered on a 25X 25cm (top) by 35X35cm(base) by 120cm(height) standard concrete square base frustum, set on the ground with protruding 20 cm on the surface with inscriptions..."GAPAN CITY NEJ BLLM NO.91, CAD 225 DENR III 2014".

ACCESS:
 The monument is located along Pan Philippine Highway in front of a vacant lot and beside the Brgy. Hall of Malimba, across the street is the Malimba Elementary School.
