<b>CAD -269- DEPARTMENT OF ENVIRONMENT AND NATURAL RESOURCES - REGION III</b>	<b>DESIGNATION: BLLM No.170</b>
	<b>PAGE: 70 / 99</b>

<b>CONTROL POINT</b> <b>Bureau of Lands Location Monument (BLLM)</b>			
ISLAND:	LUZON	CITY / MUNICIPALITY:	STA. ROSA
PROVINCE:	NUEVA ECIJA	BARANGAY:	BERANG

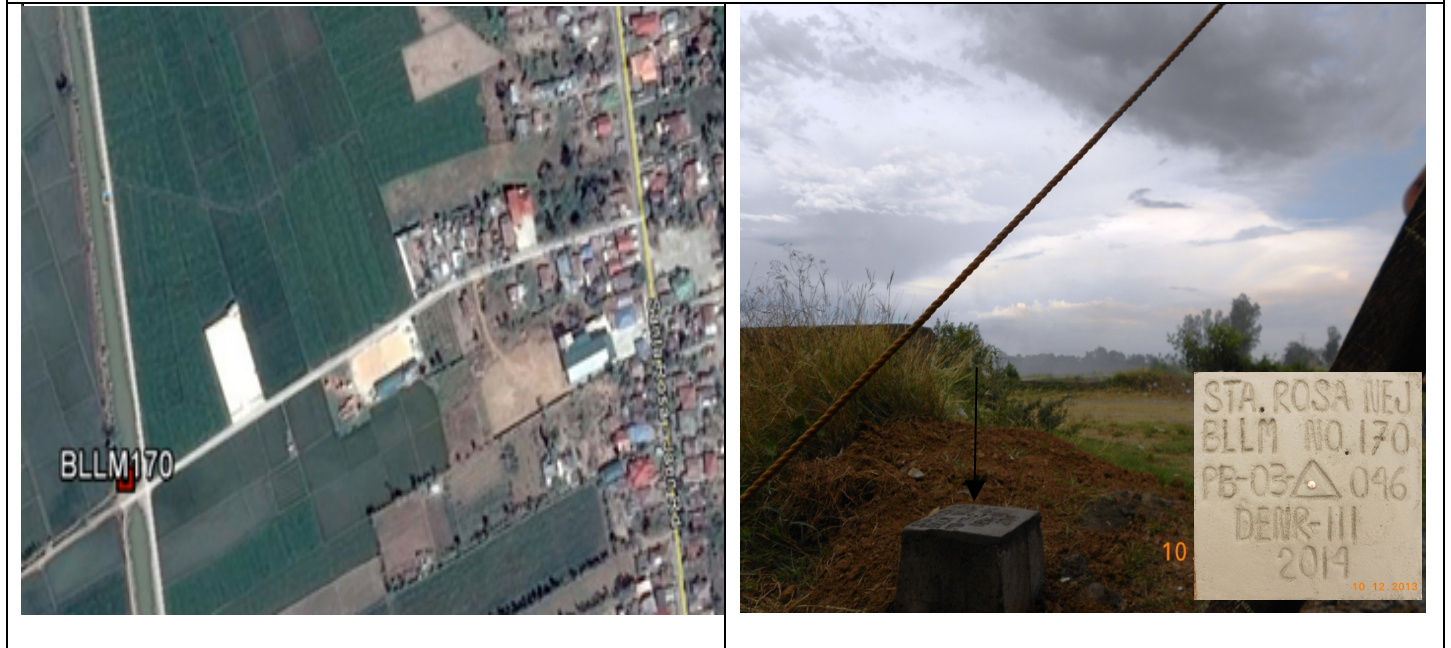
**PHOTO / SKETCH**

**DESCRIPTION:**  
 Mark is the head of a 3" copper nail embedded and centered on a 25X 25cm (top) by 35X35cm(base) by 120cm(height) standard concrete square base frustum, set on the ground with protruding 20 cm on the surface with inscriptions..."STA.ROSA NEJ BLLM NO.170, PB-03-000046 DENR III 2014".

**ACCESS:**  
 The monument is located beside the Irrigation Canal in Brgy. Berang. It is 430 meters from the Sta.Rosa-Jaen Road.
