CAD -269- DEPARTMENT OF ENVIRONMENT AND NATURAL RESOURCES - REGION III		DESIGNATION: BLLM No.175	
		PAGE: 75 / 99	
THE POINT IS MEASURED AND PERMANENTLY MARKED IN 2014 STA. ROSA CADASTRE		GEOGRAPHIC COORDINATES (WGS 84) Φ = N15°26'24.13480" λ = E120°53'40.58751"	
GEOGRAPHIC COORDINATES (OLD)		GEOGRAPHIC COORDINATES (PRS 92) Φ = N15°26'29.75495" λ = E120°53'35.76454"	
Φ =		λ =	
GRID COORDINATES (PTM) in Meter		GRID COORDINATES (PTM) in Meter N = 1707665.719 E = 488545.223	
N =		E =	
LOCAL COORDINATES (20000,20000) in Meter		ELEVATION in Meter	
X =		Y =	
		Above mean sea level 25.100	
		Ellipsoidal Height 26.670	
CONTROL POINT Bureau of Lands Location Monument (BLLM)			
ISLAND:	LUZON	CITY / MUNICIPALITY:	STA. ROSA
PROVINCE:	NUEVA ECIJA	BARANGAY:	STO. ROSARIO
DESCRIPTION: Mark is the head of a 3" copper nail embedded and centered on a 25X 25cm (top) by 35X35cm(base) by 120cm(height) standard concrete square base frustum, set on the ground with protruding 20 cm on the surface with inscriptions..."STA.ROSA NEJ BLLM NO.175, PB-03-000046 DENR III 2014".

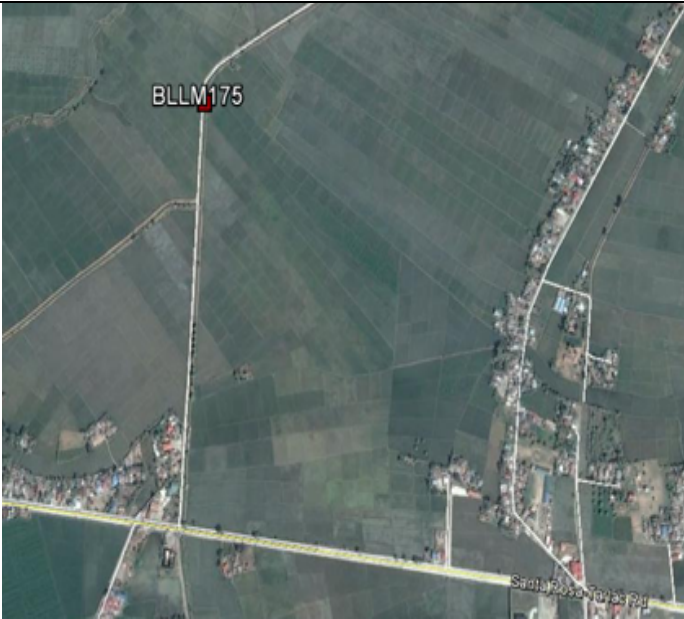
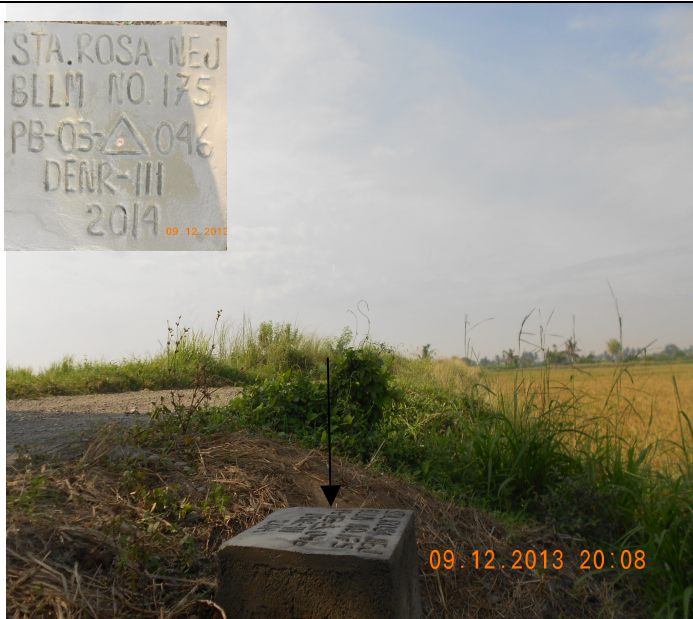
ACCESS: The monument is located along the barangay road in Brgy. Santo Rosario beside the rice paddies. It is 730 meters from the Sta.Rosa-Tarlac Road.			
SURVEYED/ DESCRIBED BY:		GeoIDEx	DATE ESTABLISHED: April 28-May 17, 2014
PHOTO / SKETCH
