CAD -269- DEPARTMENT OF ENVIRONMENT AND NATURAL RESOURCES - REGION III		DESIGNATION: <b>BLLM No.180</b>	
		PAGE: 80 / 99	
THE POINT IS MEASURED AND PERMANENTLY MARKED IN 2014  <b>STA. ROSA CADASTRE</b>		GEOGRAPHIC COORDINATES (WGS 84) Φ = N15°26'31.80118" λ = E120°52'33.49430"	
GEOGRAPHIC COORDINATES (OLD)		GEOGRAPHIC COORDINATES (PRS 92) Φ = N15°26'37.42330" λ = E120°52'28.67141"	
Φ =	λ =	GRID COORDINATES (PTM) in Meter	
GRID COORDINATES (PTM-OLD) in Meter		N = 1707902.475	E = 486545.186
N =	E =	ELEVATION in Meter	
LOCAL COORDINATES (20000,20000) in Meter		Above mean sea level	23.460
X =	Y =	Ellipsoidal Height	24.965
<b>CONTROL POINT</b> Bureau of Lands Location Monument (BLLM)			
ISLAND:	LUZON	CITY / MUNICIPALITY:	STA. ROSA
PROVINCE:	NUEVA ECIJA	BARANGAY:	RAJAL NORTE
DESCRIPTION: Mark is the head of a 3" copper nail embedded and centered on a 25X 25cm (top) by 35X35cm(base) by 120cm(height) standard concrete square base frustum, set on the ground with protruding 20 cm on the surface with inscriptions..."STA.ROSA NEJ BLLM NO.180, PB-03-000046 DENR III 2014".

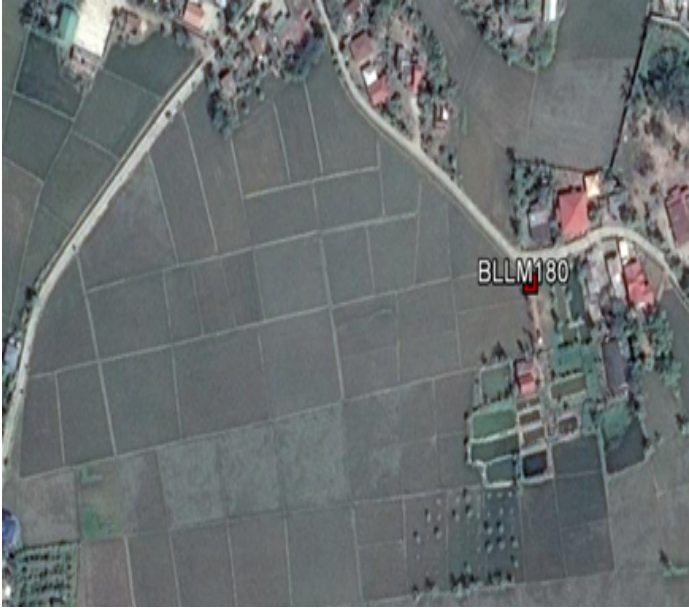
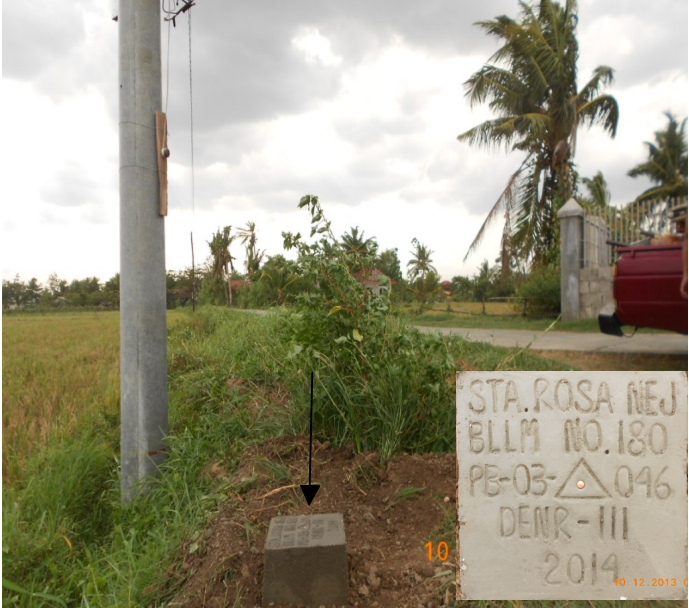
ACCESS: The monument is located at the right side of the barangay road, about 500 meters after the Barangay Hall of Rajal Norte. It is 1.2 Kilometers from the Sta.Rosa-Tarlac Road.			
<b>SURVEYED/ DESCRIBED BY:</b>		<b>GeoIDEx</b>	<b>DATE ESTABLISHED:</b> April 28-May 17, 2014
PHOTO / SKETCH
